# Poplar Baths by Pringle Richards Sharratt

Poplar Baths in London's East End is a historic example of state architecture used to improve public health. But to preserve this listed building, the project team had to demolish part of it and rebuild through a PPP agreement

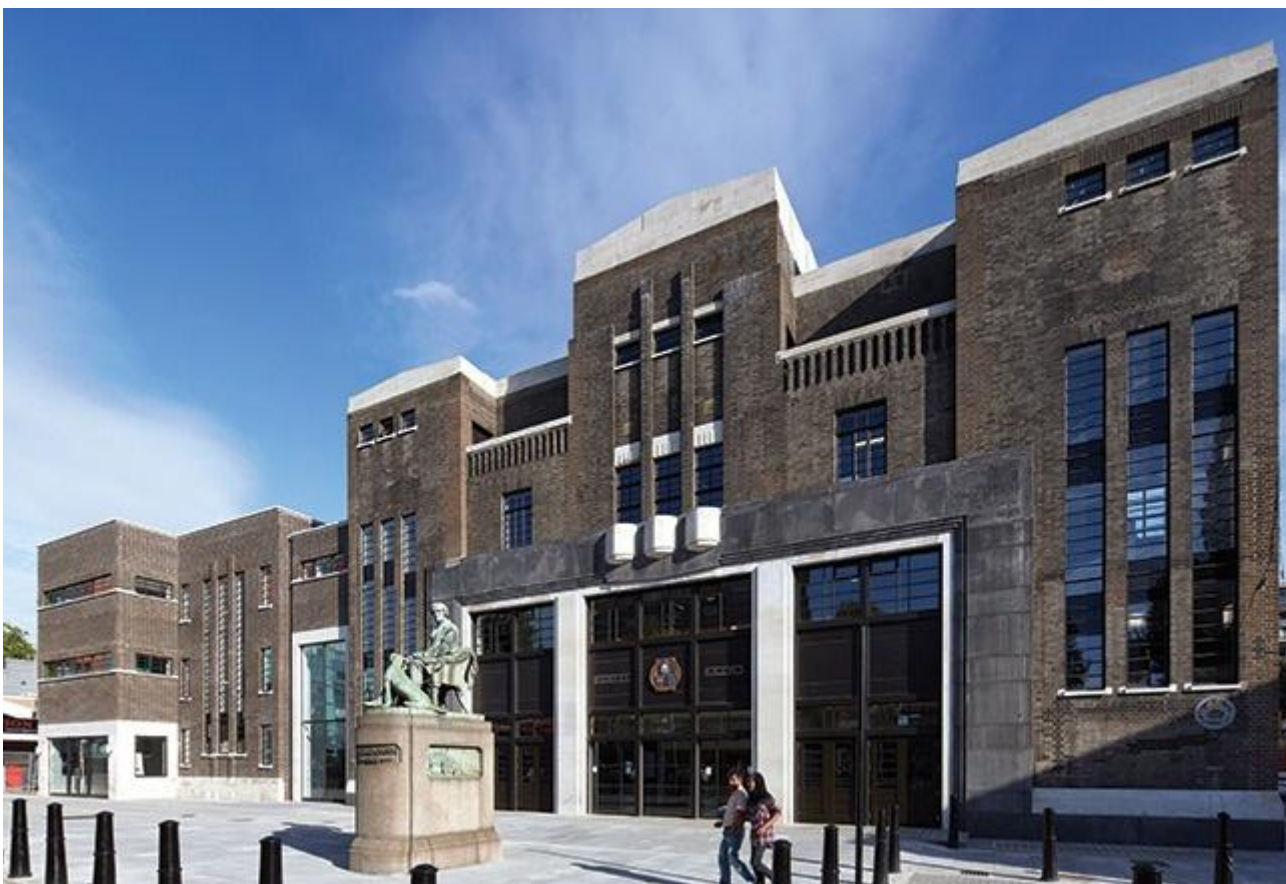
The restored frontage sits alongside the new-build block to the left

Externally, brickwork and stone dressings have been repaired and restored and the brickwork and elevational treatment applied to the new wing matches its demolished predecessor as closely as possible. Quinlan also reveals that original features of particular historic or decorative interest that have not as yet been redeployed in the new scheme have been carefully stored in a new "heritage room" inside the building.

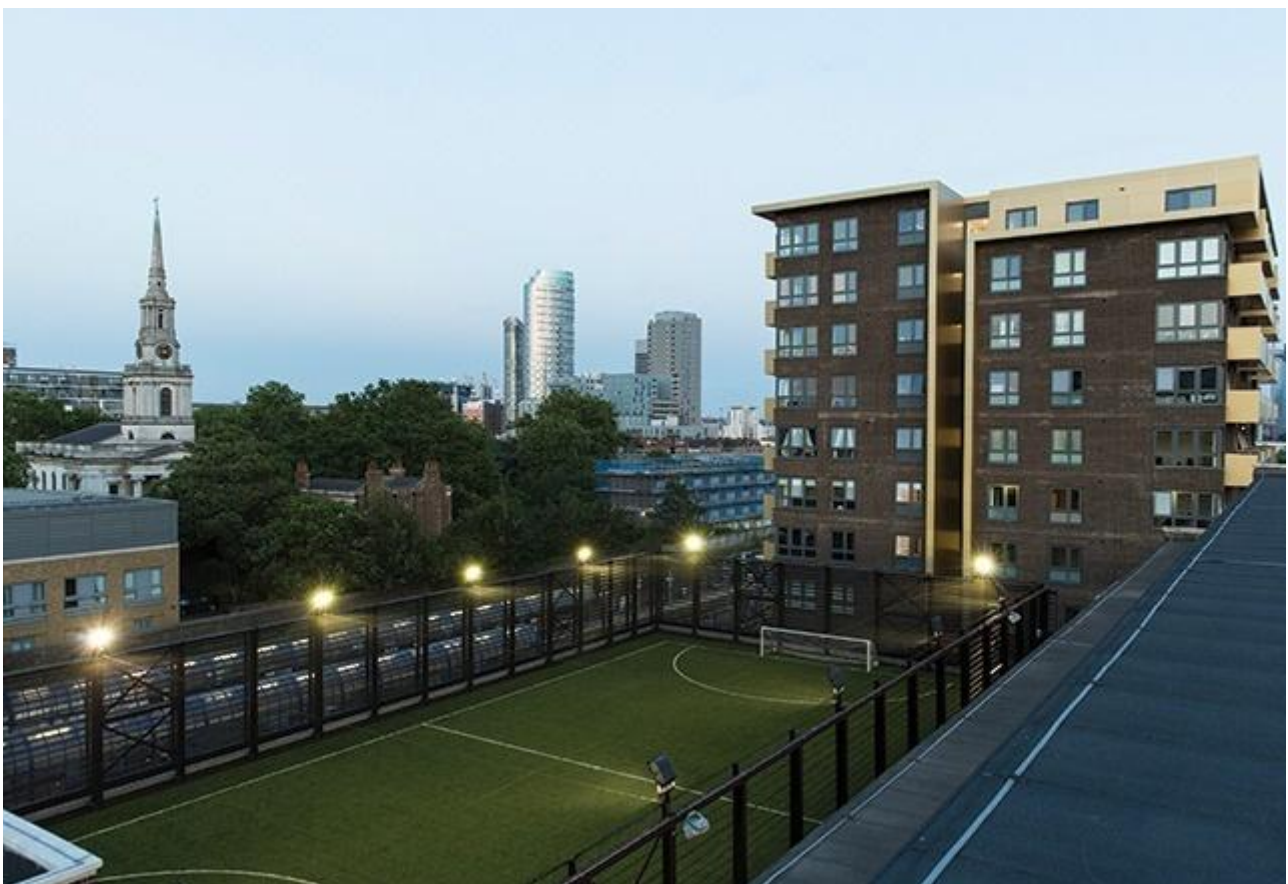
A new rooftop football pitch has been built above the newbuild block

By eliminating the pool from the primary building, the ground floor area that previously accommodated the pool basin has now been allocated as a continuous plant level that serves the entire building, with the changing rooms retained and refurbished below. In place of the demolished block next door, the new pool occupies the lowest two levels while a new gym has been located above this. In a further ingenious twist, a rooftop football pitch has also been created to expand the venue's leisure facilities.

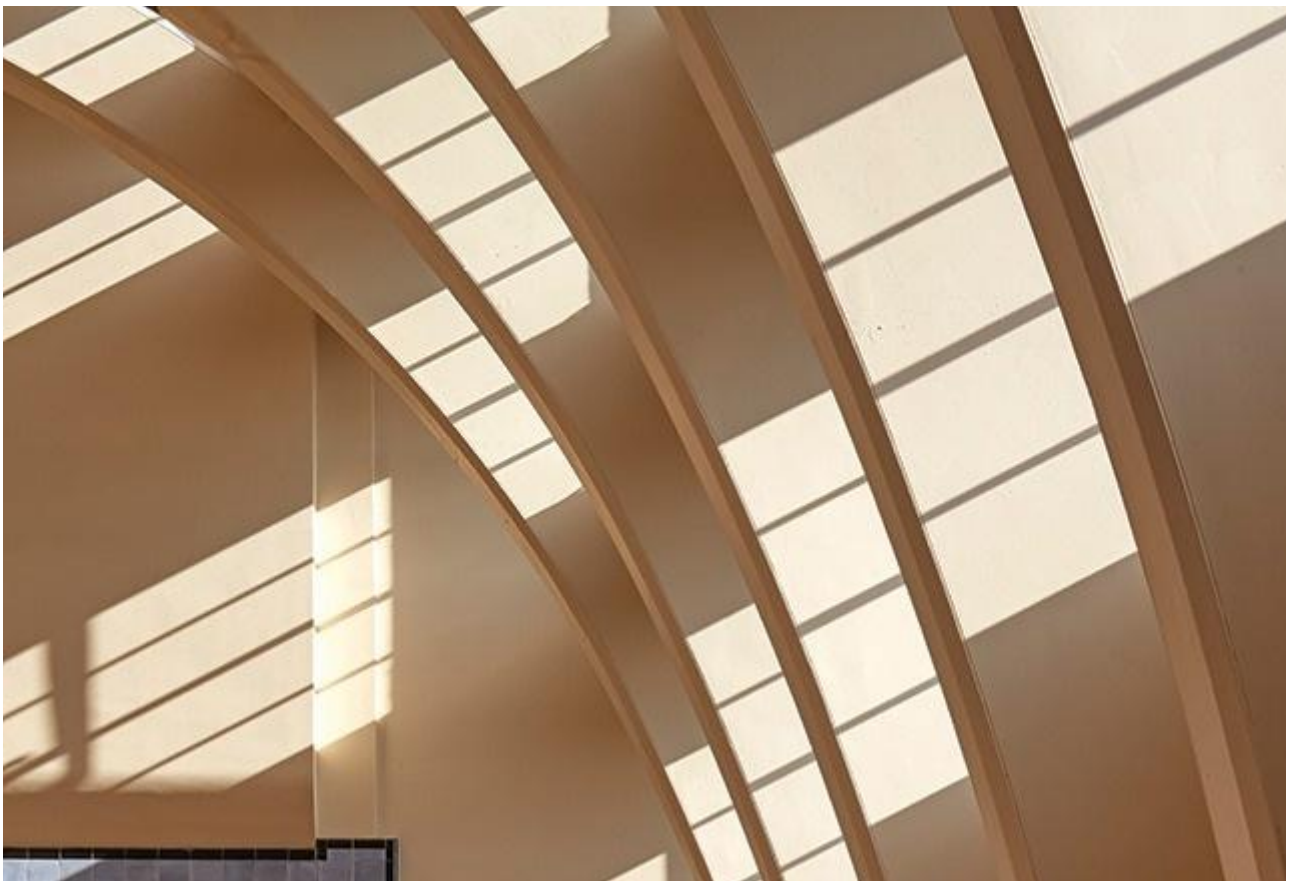
Refurbished concrete arches span the original pool hall
